# Tek talk

"hot off the roof"

**E-las-tek®**  
CERTIFIED COOL ROOF COATINGS

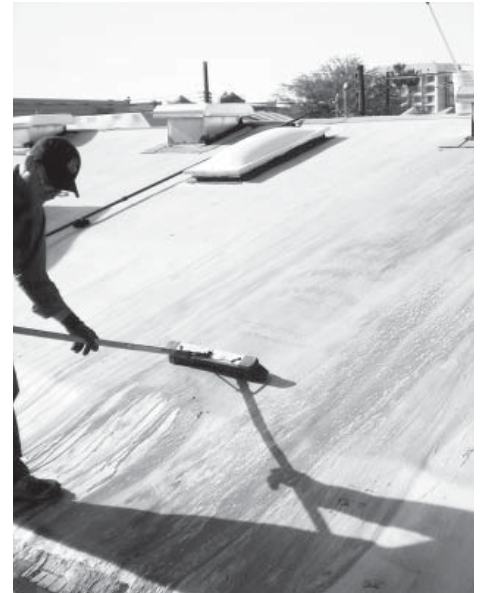
*First, clean the roof thoroughly with TSP or TSP substitute, push broom, and water.*

The first is to clean the roof very well with TSP or TSP substitute, push broom, and water. Mix the TSP substitute to the proper amount of water and spread over an area on the roof. Let the solution stand for a few minutes and scrub vigorously with a stiff bristle push broom. A power washer can also be used. Rinse the area with a garden hose to remove the TSP and loose aluminum flakes. Let the area dry and conduct a tape test with a strip of masking tape. If the tape has no or very little aluminum flake on the bottom after you have pulled it up, then the roof is ready to be coated with two coats of Elastek roof coating at the recommended rates with 24 hours dry time between coats. It is always best to do

multiple tests over the entire roof to ensure that there are no areas that need a second cleaning. If the tape collects a lot of aluminum flakes, the roof will need to be cleaned again and another tape test performed. Repeat this step until there is little to no aluminum on the back of the tape.

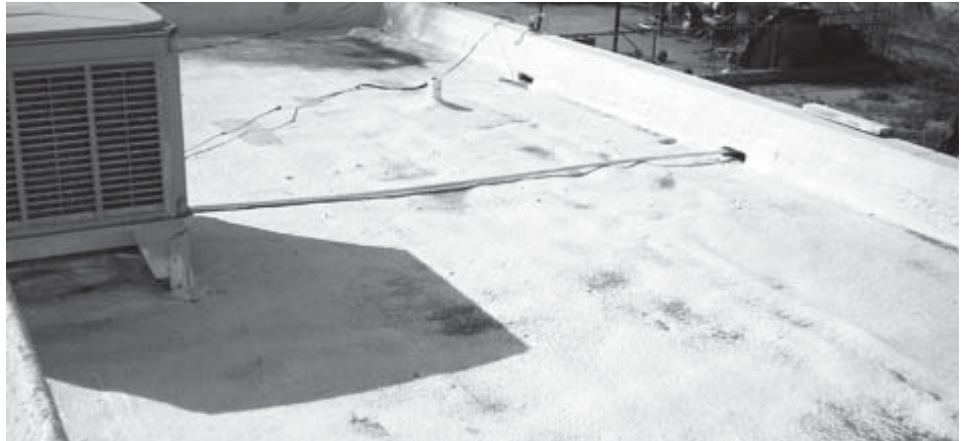
*Note the contrast of dark areas and light areas and the foam domes, indicating a need to coat.*

It can be difficult to determine if a coating is thick enough to protect the underlying foam. If the coating is gone and the foam has been exposed to the sun for any length of time, the foam will turn "orange" or "rust" colored. Just because the top of the foam is burnt, it does not mean the foam roof is no longer able to be saved. A professional roofing contractor who specializes in application of foam roofs will be able to determine if the system can be salvaged.

If there is still coating on your foam roof, there are a couple of ways to determine if it needs to be coated. Inspect your roof wearing polarized sun glasses, which will reduce the glare put off by the coating and allow you to see the different patterns from the previous application. If the pattern is darker while surrounding areas seem to be lighter this indicates the weathering pattern of your coating. The darker areas show where the coating is thinning and the foam substrate is starting to be exposed to the UV light. A sample of the coating

can be peeled back from the foam and measured with a micrometer. If the coating is less than 15 mils thick or appears translucent, it's time for a new coating to be applied.
